Rockfall Mitigation

On I-70

Eliminating the hazard of falling rocks on mountainous highways is impossible, but the risk can be substantially reduced

Rockfall

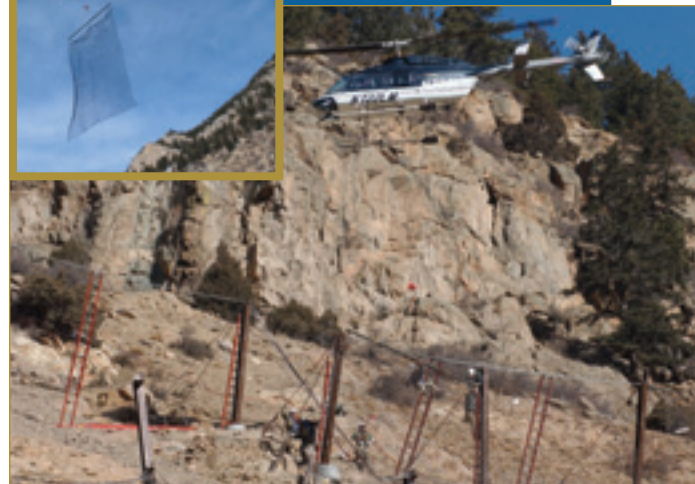
Once the mesh is securely fastened to the frame, it is disconnected from the helicopter.

At the installation site, the crews on the ground grabbed a tagline to maneuver the mesh into place and attach it to the

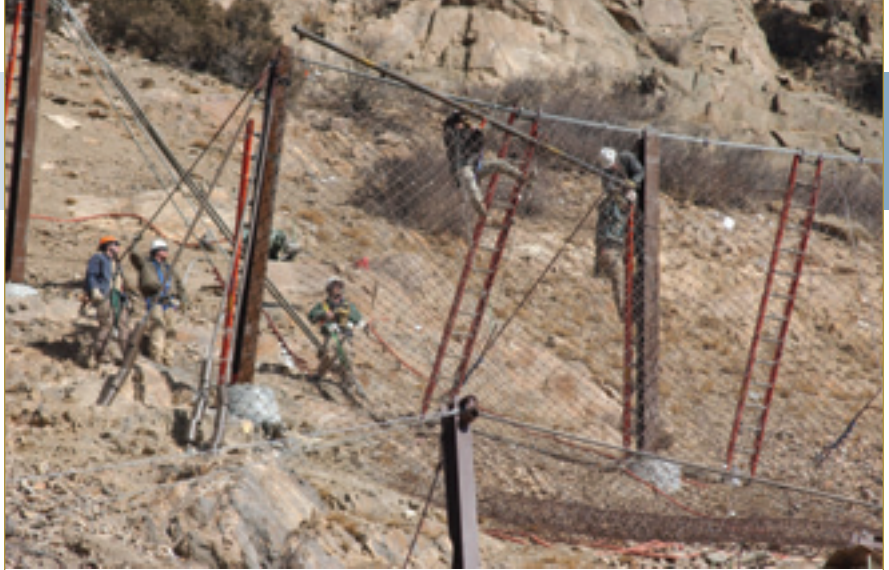
Above: Crews secure the 1,200-pound piece of mesh into a huge chain link fence. This extra-strong mesh is similar to chain link mesh used underwater by the military to seize submarines.

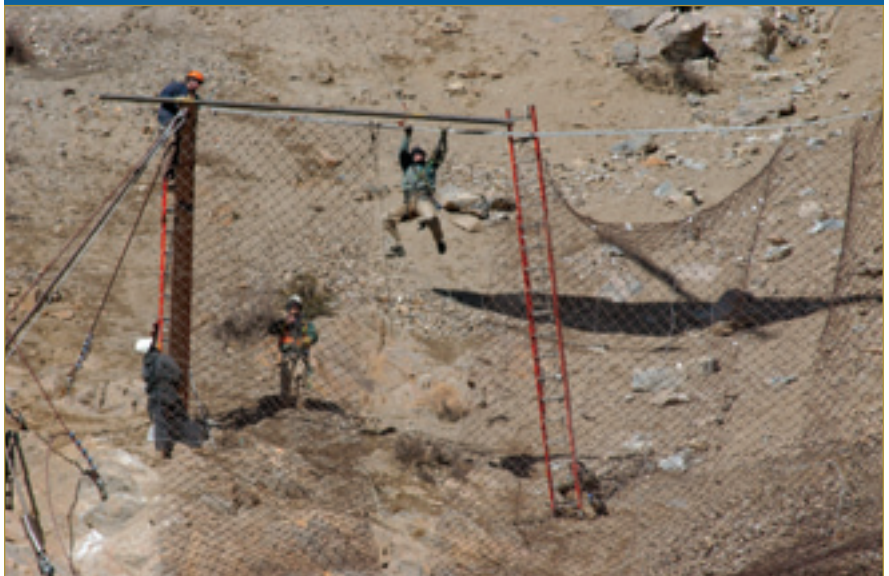
Above: From their precarious perch on the mountainside, ground crew members dangle as they secure the mesh.
