# Rockfall Mitigation

## On I-70

**Eliminating the hazard of falling rocks on mountainous highways is impossible, but the risk can be substantially reduced**

# Rockfall

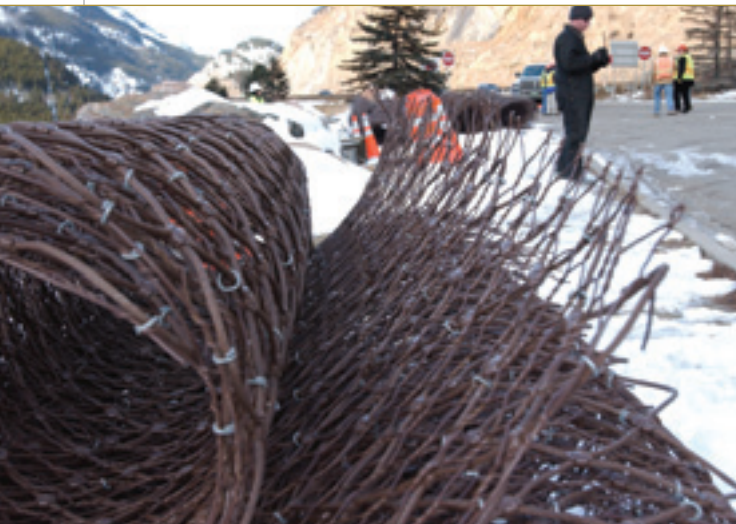
Coiled wire mesh sections rests on the side of I-70 awaiting helicopter hoist to construction side on Georgetown Hill. Georgetown Hill photos by John Gross, CDOT

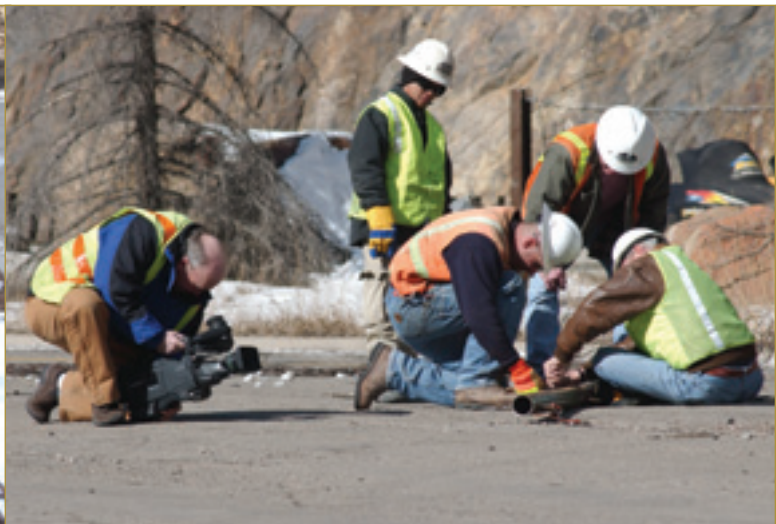
Crews prepare the metal spreader beam that will be attached to the wire mesh top to keep it from crumpling during transport.

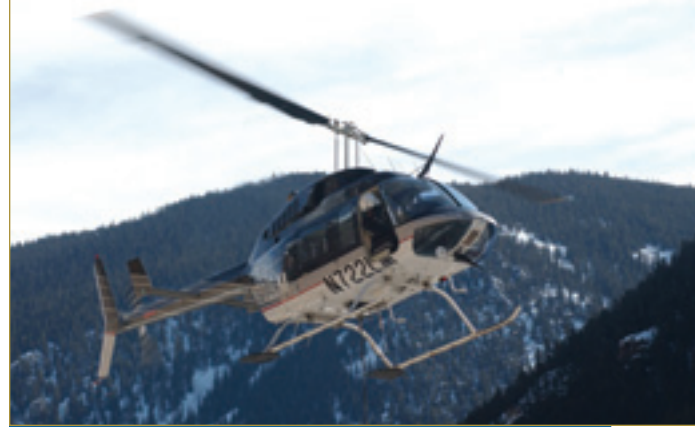
Above: The pilot carefully maneuvers a jet-powered Bell 206 L-4 Long Ranger over the chain link section where the ground crew attaches it for hoisting. The pilot is the only person on board to keep weight low at this high altitude. Inset: The chopper carefully lifts the heavy mesh before heading across I-70 to the rock fall mitigation area. High winds, common in mountainous areas, can challenge aerial deliveries even for experienced pilots. Below: The chopper pilot deftly lowers the mesh over the steel framework.

As the first step, the workers drilled the anchors 6 feet deep for the columns. Then the first helicopter hoisted in the 750-pound, 15-foot-high steel columns, and the crew anchored them into the holes with concrete. The next step was attaching the 1,200-pound sections of metal netting. This extra strong mesh is similar to chain link mesh used underwater by the military to seize submarines. Workers attached the top of the 15-foot-wide by 30-foot long chain link to a spreader beam to prevent it from crumbling during transit. Then workers kept the mesh spread out as the helicopter picked it up. Due to the weight of the chain link sections and the high altitude, the pilot was the only one on board the helicopter. Also, the helicopter carried just 10 gallons of fuel and refueled between each lift.

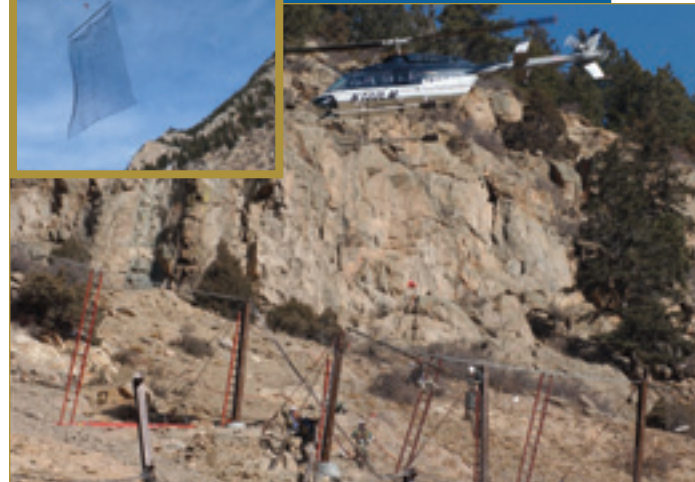
Once the mesh is securely fastened to the frame, it is disconnected from the helicopter.

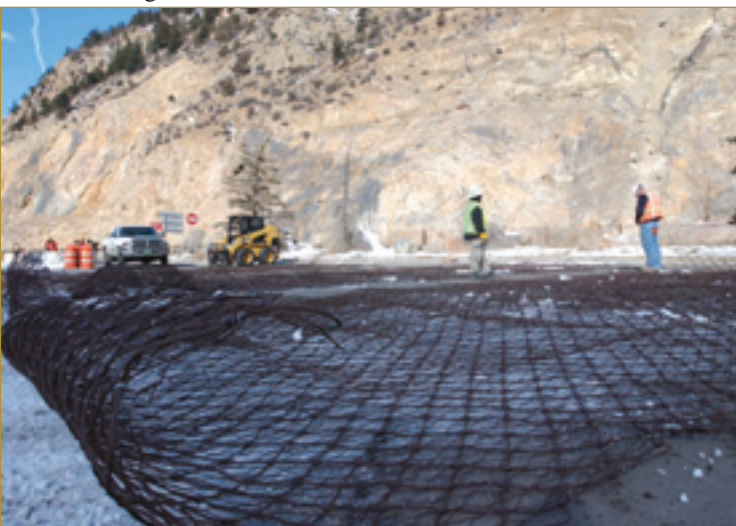
The mesh resembles a large chain link fence with sections 15 feet wide by 30 feet long and weighing 1,200 pounds.

The 12-foot-high bottom fence is 2,400 square feet, and the 15-foot-high fence on the mountainside is 1,100 square feet. The composition of the netting is 5/16-inch-diameter 6-inch diagonal weave cable net with wire mesh connected on the uphill side. One-half-inch wire support ropes are connected to the netting in a diagonal pattern to add additional support and weight. The netting is suspended from the 1-inch wire support ropes and is draped for approximately 15 feet on the ground.

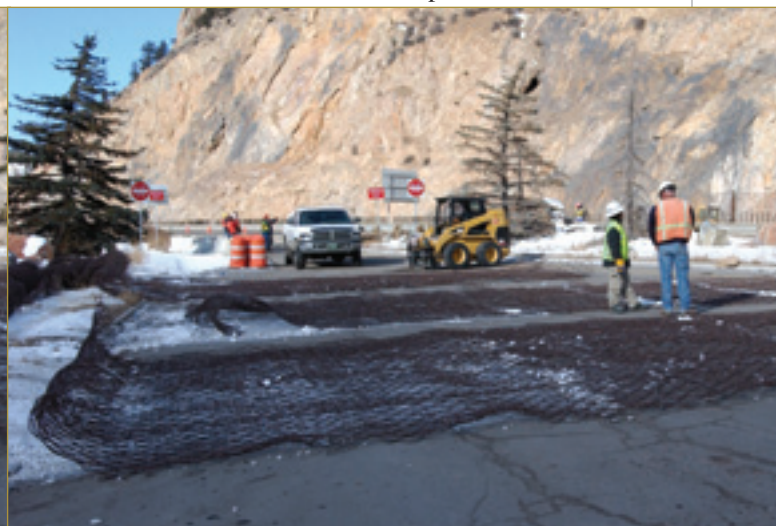
A worker reaches for the spreader beam that will be used to hoist the mesh section. Keeping the mesh spread out as it's picked up by helicopter is tricky.

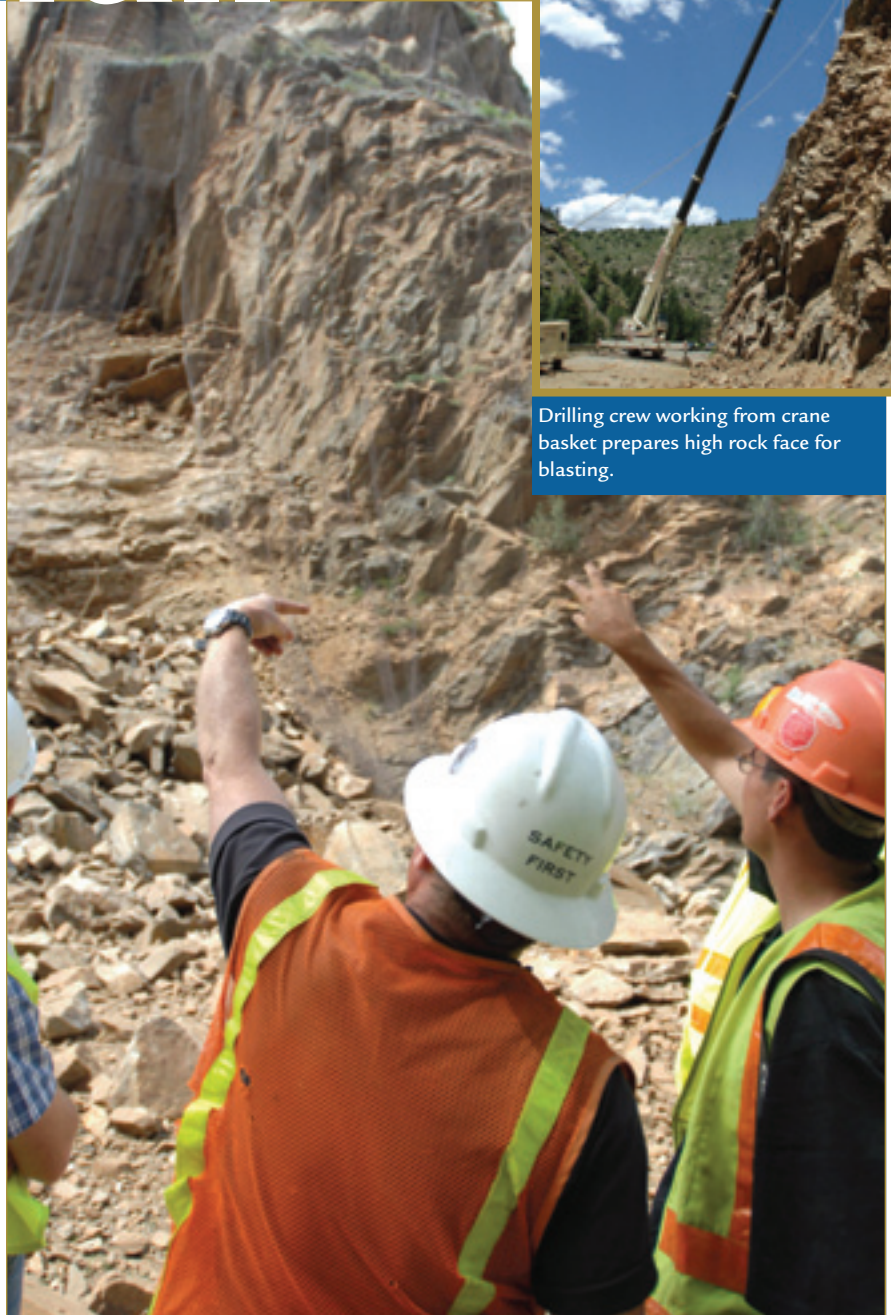
Drilling crew working from crane basket prepares high rock face for blasting.

Tom Flick, Ames Construction project manager, expected to move to two 10-hour shifts the week of July 10 “as soon as the canyon is opened up a bit.” Ames is handling the blasting with in-house expertise to remove the bedrock judged unstable by CDOT geologists. Subcontractor Hark Drilling of Phoenix is stabilizing the rock face with rock bolting and wire mesh netting.

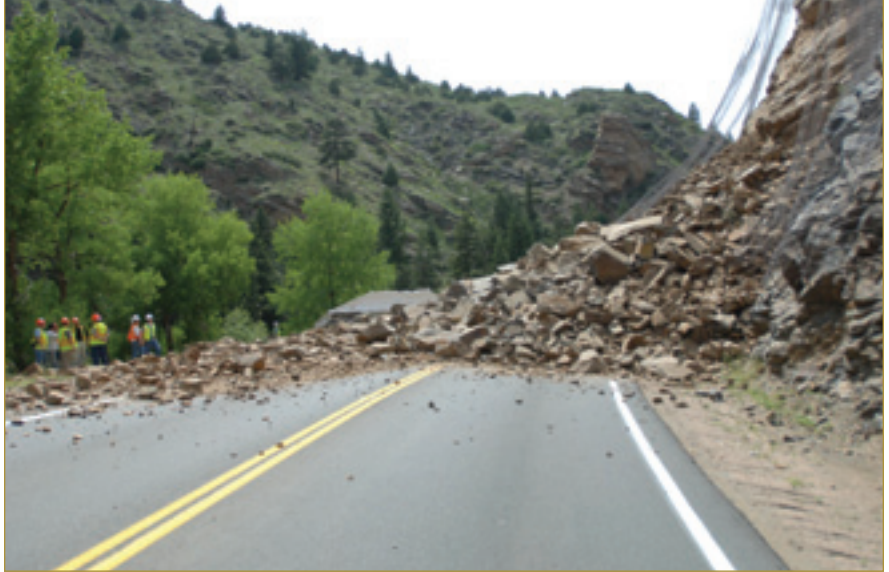
View of rocks on road. Note that wire stabilizing mesh installed last year still hangs from its top anchors.

“Geologic hazards are inherent along the mountain highways in Colorado. Landslides – debris flows – avalanches – and rockfall,” begins the audio for the video Colorado Department of Transportation prepared on the I-70 Georgetown Hill mitigation project. “Some forces of nature are unstoppable and unpredictable,” CDOT geologist Ty Ortiz remarked. Mother Nature illustrated the truth of that statement on Tuesday, June 21, at 11 a.m. when 1,500 tons of rock slid off a 150-foot-high outcropping on a corner of US-6 just a mile and a half east of the SH-119 junction. A known trouble spot, the slope was draped with wire mesh net last year, but the rock slid right under it leaving the top anchors intact.

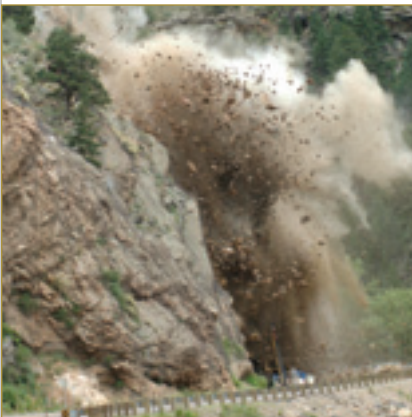
The blast – cloud of dust with lots of rocks in air.
